Design Testing Highlights

Level II Team 18

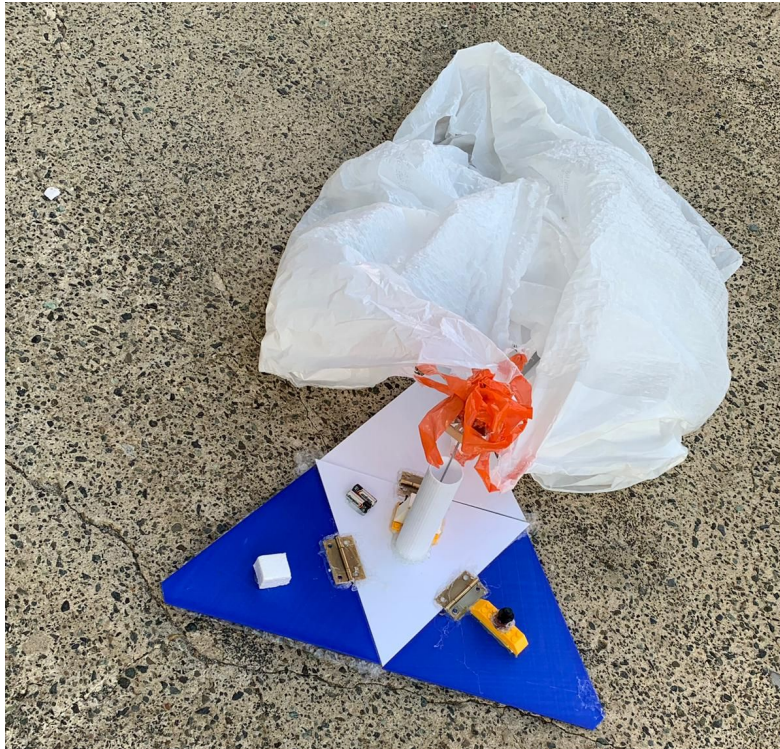
Figure 1: Lander with Deployed Payload

Design Review: The triangular pyramid design proved to be optimal for rough landing and protecting the science payload. In many failed attempts the main body managed to escape almost completely unscathed from the drop. The bubble wrap helped to absorb part of the impact; justifying the use of airbags for extra protection on the design. Having said that, the most troublesome part was the parachute deployment. Most of the failed attempts came from the parachute coming off from the lander before touchdown and leaving the payload free falling from two or three meters. To work around the problem the design was tweaked a bit. The team decided to add friction at the base of the pyramid using hot glue where the release button of the parachute is located. This way we avoid the early deployment of the parachute since a little bit of force is needed to move the mechanism, a force that could only be provided by the impact.

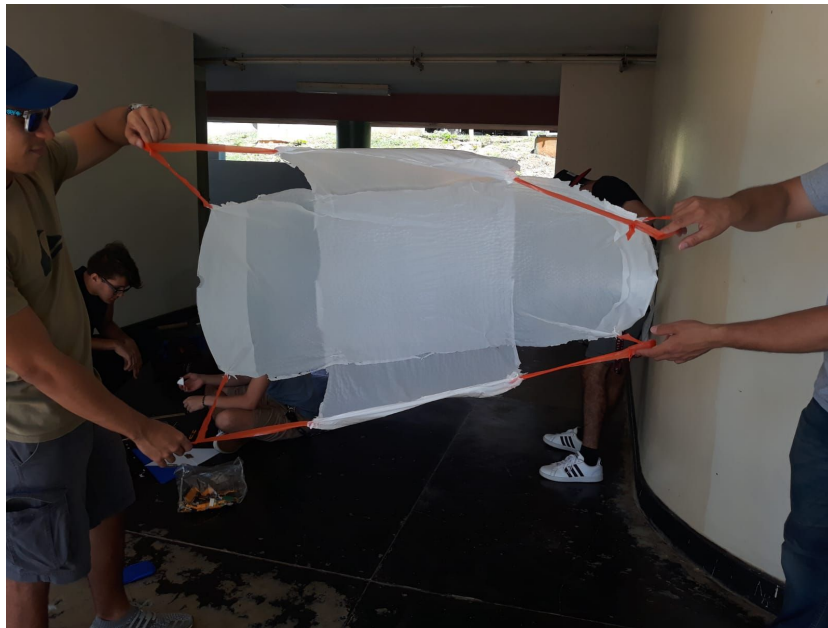
Figure 2: Parachute Manufacturing and Testing
